Manhole Inspection Summary

Manhole # S51QQ_011MH

Insp Date: **3/17/08 1:35 PM**

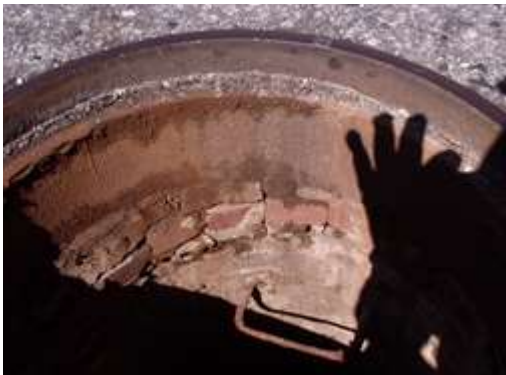
Defect 1

Condition: ☐ Sound ☐ Cracked ☐ Root Intrusion ☒ **Loose Brick** ☐ Deteriorated

Infiltration: ☐ None ☐ Joint ☐ Cracks ☒ **Mortar** ☐ Roots ☒ **Wall**

Adjustment Joint

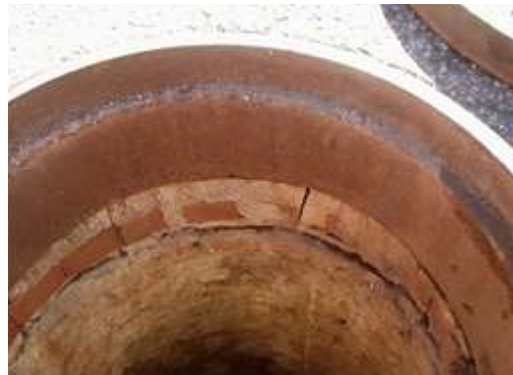
Defect 2

Frame Offset: **2** (in.) Condition: ☐ Sound ☐ Cracked ☒ **Leaks**

Frame Leaks

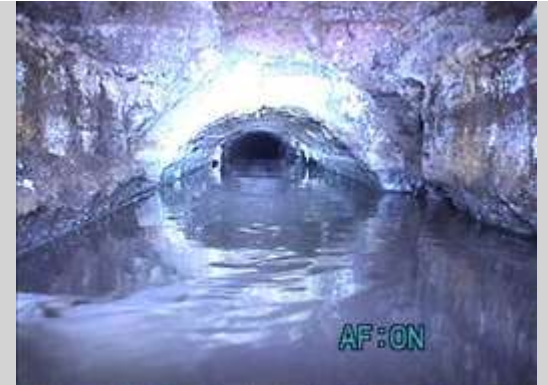
12 O'Clock Outflow

8 in. Circular Gravity Sewer
Pipe Out @ 12 O'Clock

Pipe Height: **8.4** (in.) Rod and Bar (Angled)
Pipe Material: **Clay** ☐ Pipe Lined
Invert Depth: **10.70** (ft.) Flow Characteristics: **Slow**
Deposits: ☐ None ☐ Mud ☒ **Sludge** ☒ **Debris** ☐ Grease
Silt Depth: **4** (in.) Deposits Extent: **Medium**
Infiltration: **None** Pipe Seal Cond: **Sound**

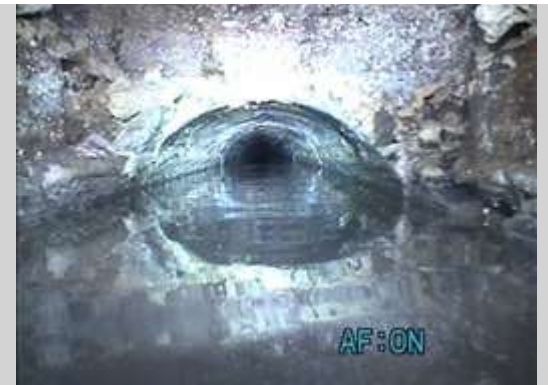
6 O'Clock Inflow

8 in. Circular Gravity Sewer
Pipe In @ 6 O'Clock

Pipe Height: **8.4** (in.) Rod and Bar (Angled)
Pipe Material: **Clay** ☐ Pipe Lined
Invert Depth: **10.60** (ft.) Flow Characteristics: **Slow**
Deposits: ☐ None ☐ Mud ☒ **Sludge** ☒ **Debris** ☐ Grease
Silt Depth: **4** (in.) Deposits Extent: **Medium**
Infiltration: **None** Pipe Seal Cond: **Sound**
